# WATERSIDE VALLEY Masterplan & Management Plan

**WESTFIELD**  
Parish Council

October 2022

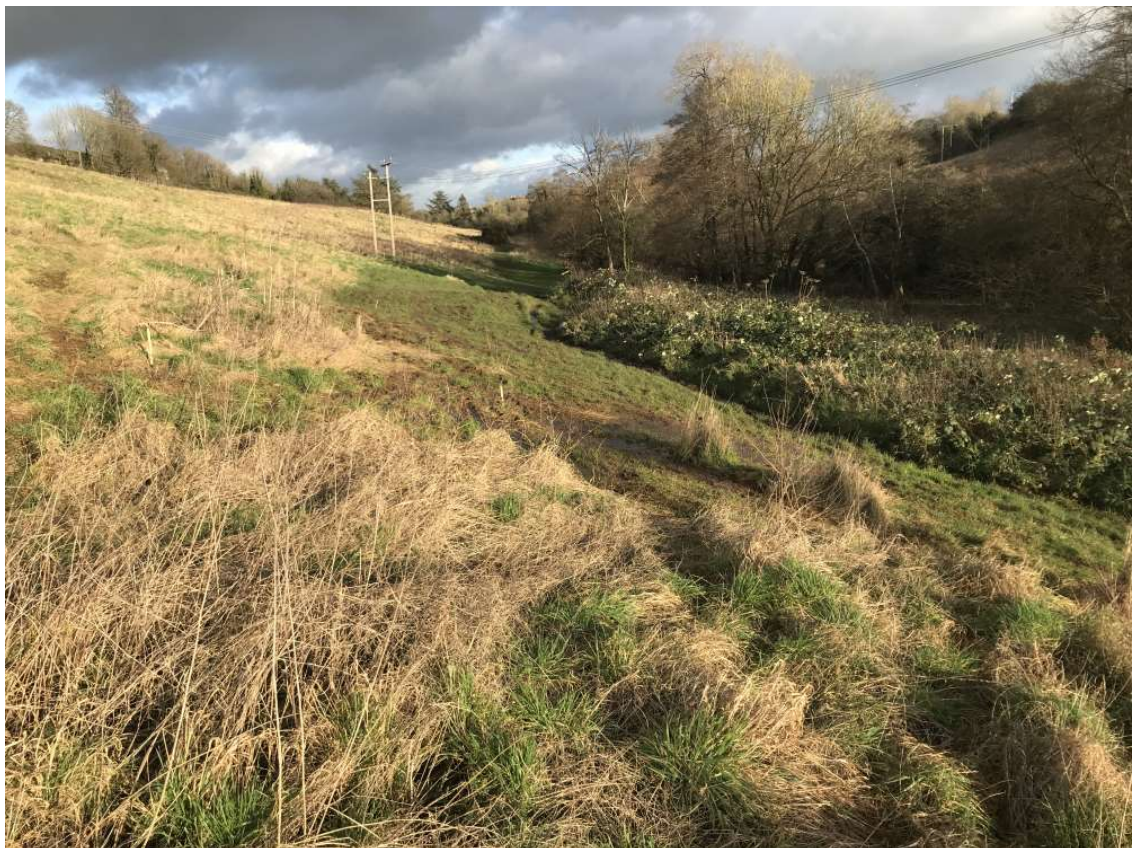
Generally the land falls by around 15-25m from the top of the slope to the watercourse with gradients ranging from 1:3.7 to 1:4. There are some localised steeper areas and some more level areas towards the bottom of the slope.

**Figure 6** – general view of NE field, looking north, showing typical topography of SE facing slope from development boundary on the ridge down to the Waterside

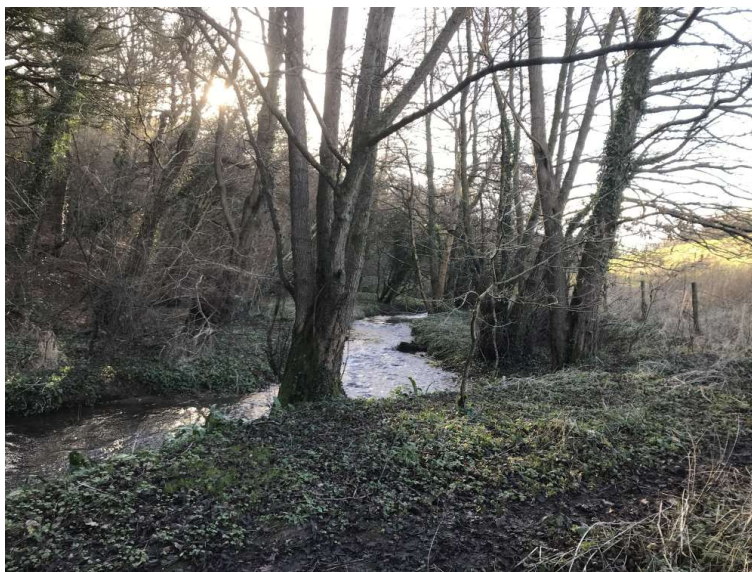
**Figure 7** – Waterside - general view looking upstream

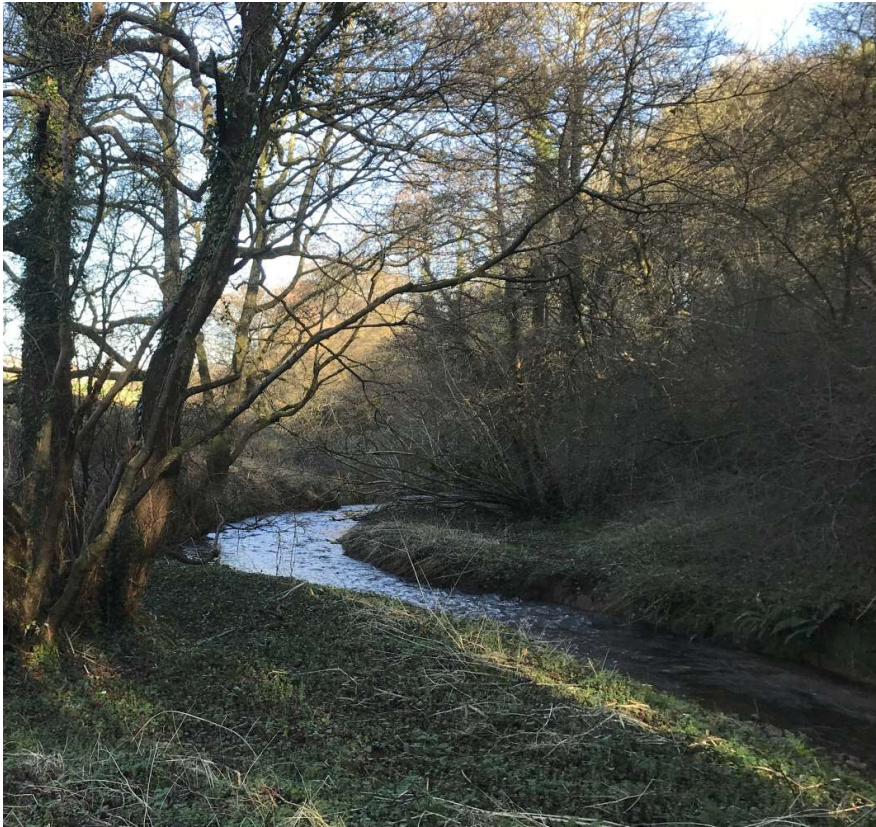
The natural meanders of the watercourse are a valuable feature both in ecological and human enjoyment terms, providing a variety of bank profiles and a mix of wider slower moving sections of water and narrower faster moving sections. This provides a potential for educational use in relation to teaching physical geography or river ecology.

**Figure 8** – Waterside - general view, gentle meanders

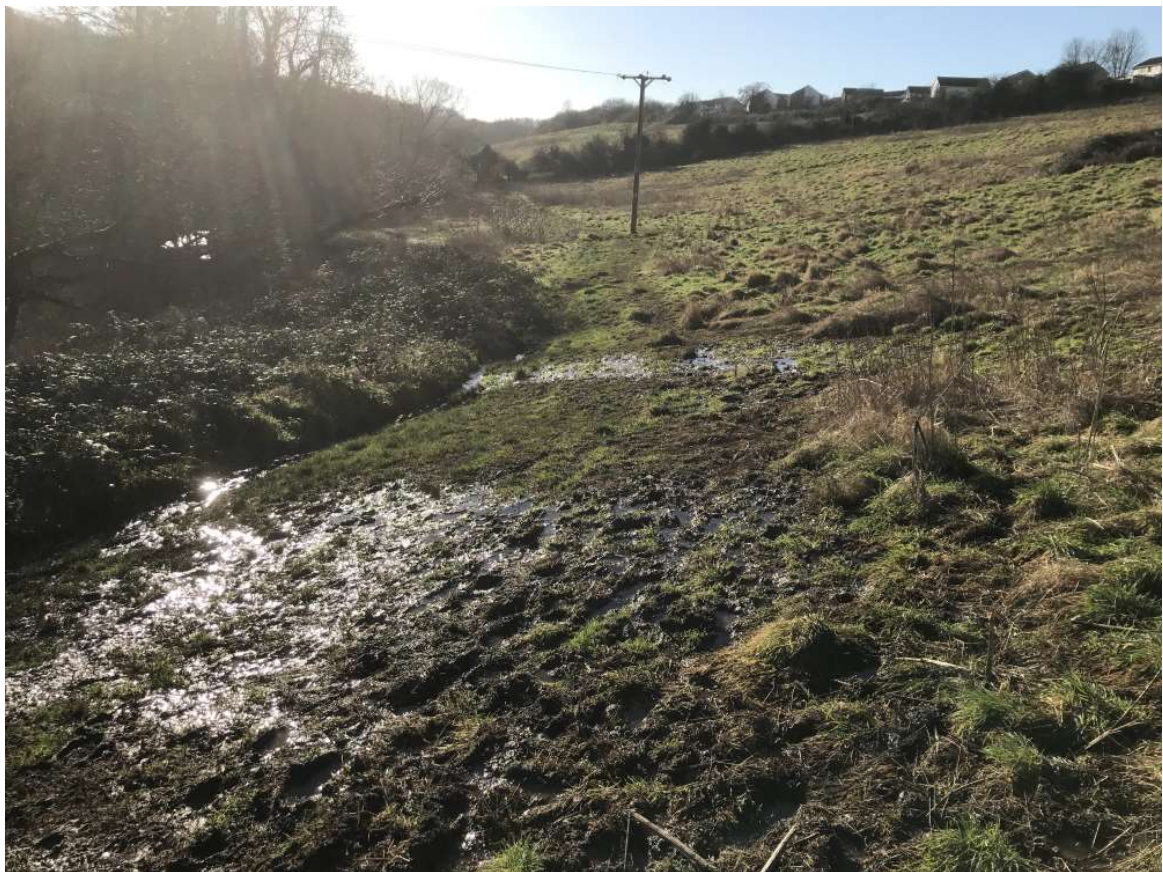
**Figure 10** – One of the point where water from a spring crosses the lower path making it muddy for long periods of the year.

In a number of locations springs or issues emerge from the lower half of the slope. In some cases there may be a distinct point of emergence, in others cases a more diffuse seepage from a wider area of the slope. It is assumed that they are natural springs, but they could also be outfalls from land drains or surface water drains further up the slope.

While these springs cause problems with muddiness of the lower path, they also present an opportunity for providing an attractive feature with potential for providing a further variant of wetland habitat on site.

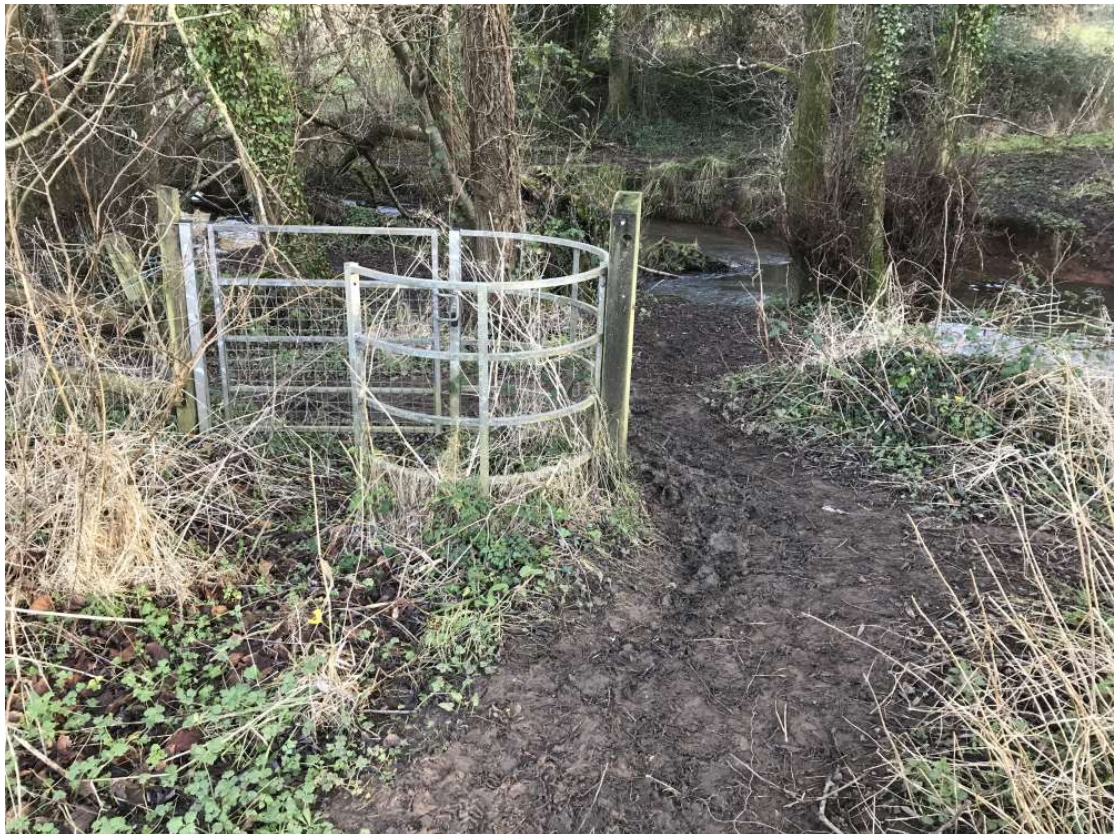
**Figure 12** – Redundant and by-passed kissing gate near Entrance E

Most of the entrance points have kissing gates and gate furniture that with the cessation of grazing and no plans to reintroduce it, are now redundant. Many have also been by-passed so now at best add un-necessary clutter but in some cases also present a barrier to full accessibility or hazards with sharp metal edges and remnants of barbed wire.

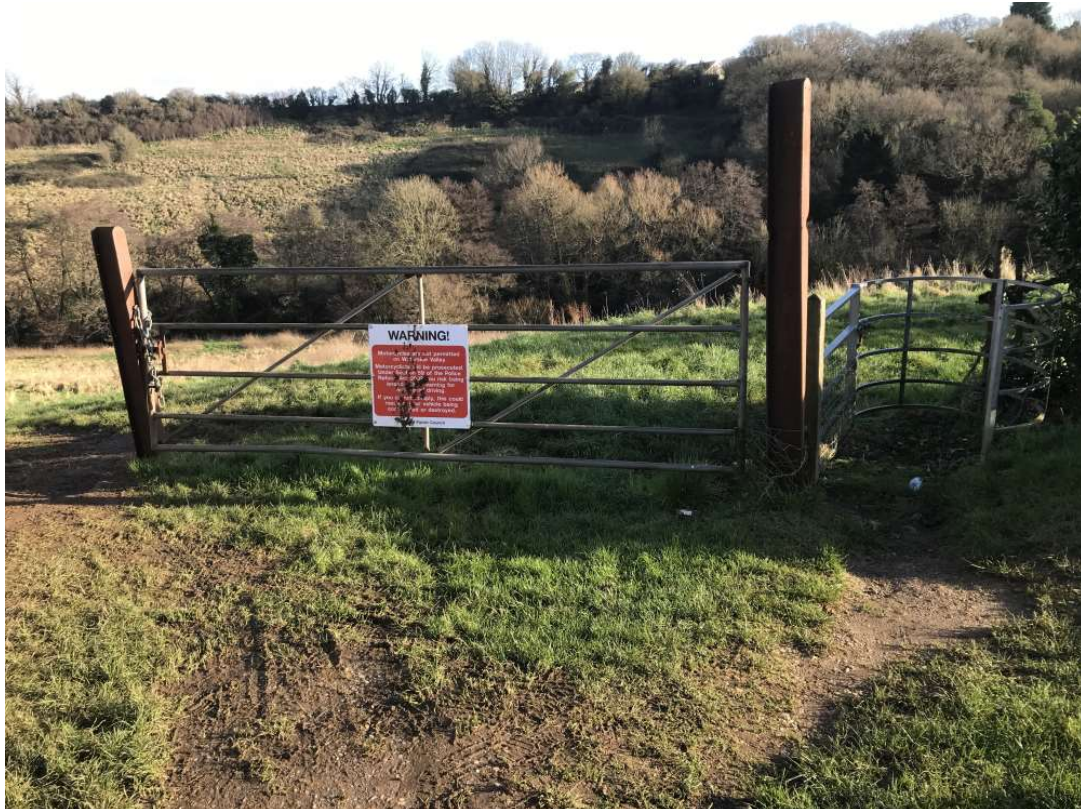
**Figure 13** – Redundant and by-passed kissing gate and field gate at Entrance A presents an unwelcoming feel.

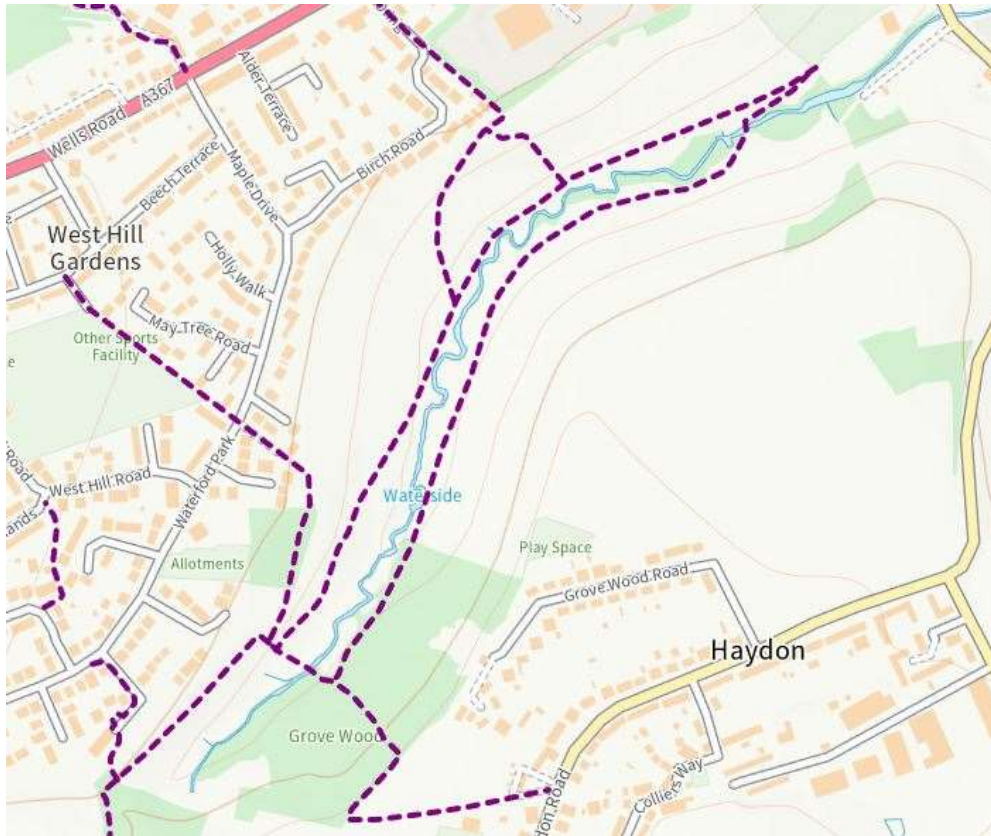
**Figure 14** – Public Right of Way routes through and in the vicinity of the site

In addition to the official PRWO routes there are numerous informal desire line paths crossing the site. These too are identified on drawing WPC740/Drg01 Site Survey & Analysis.

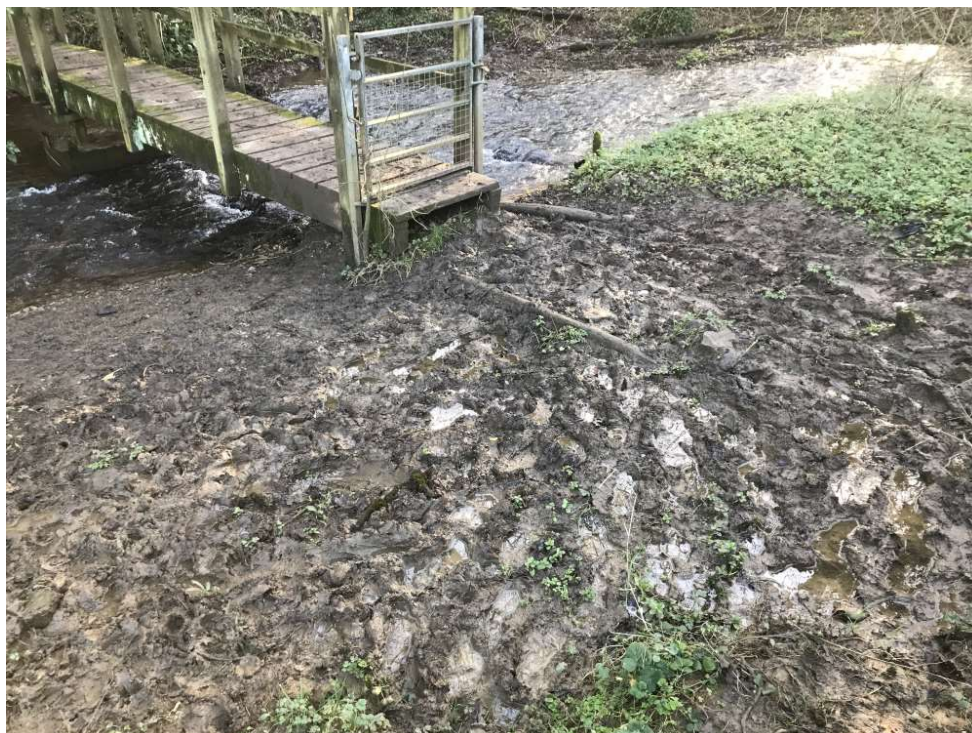
**Figure 15** – Extreme level of mud by footbridge near entrance H

Many paths, especially but not exclusively in the lower areas of the site become very muddy for the wetter months of the year. These muddy areas are a significant barrier to year round use by all but the most determined welly wearing visitors.

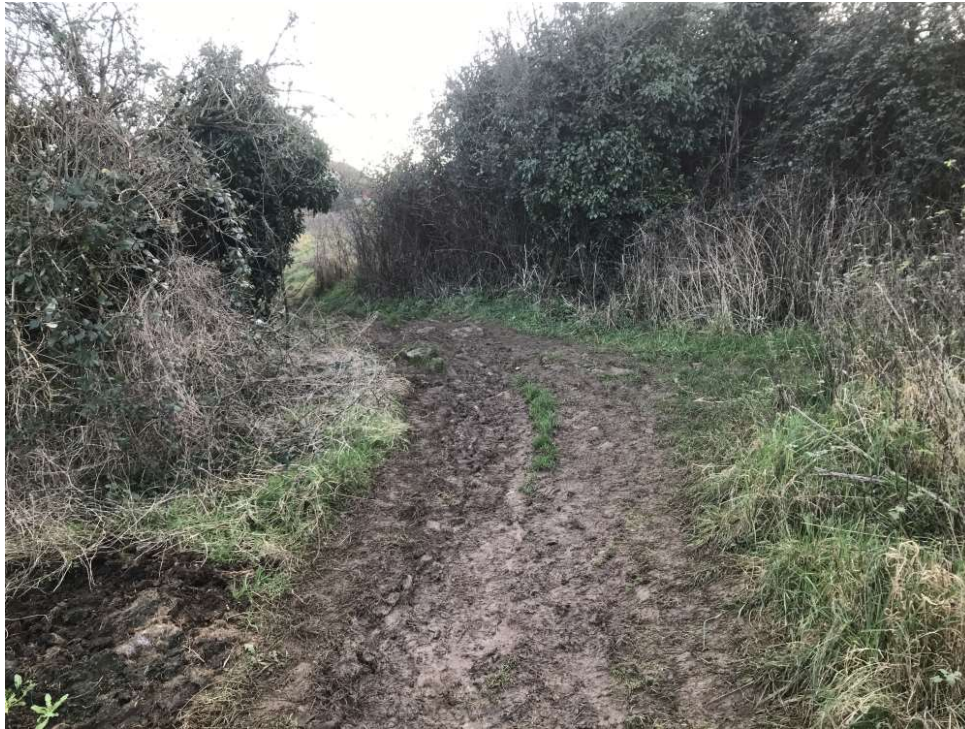
*Figure 16 – Muddy section of upper path where it passes through the dividing hedgerow*

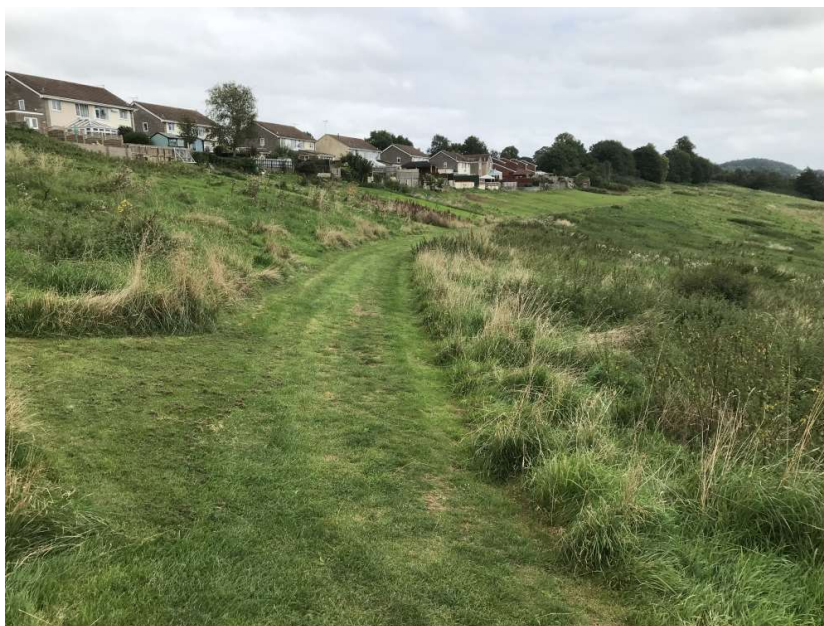
This is grassland that has been modified by human activity, predominantly by way of increasing soil fertility as a result of direct fertilization or accumulated waste from livestock. It is dominated by a low number of fast growing, coarse grass species, typically on neutral soils, with relatively few wild flower species, less than nine species (grass and wildflower) per m<sup>2</sup>.

**Figure 17** – Modified grassland to either side of mown path (September 2021). Note the coarse grasses and establishing patches of nettle (darker areas)

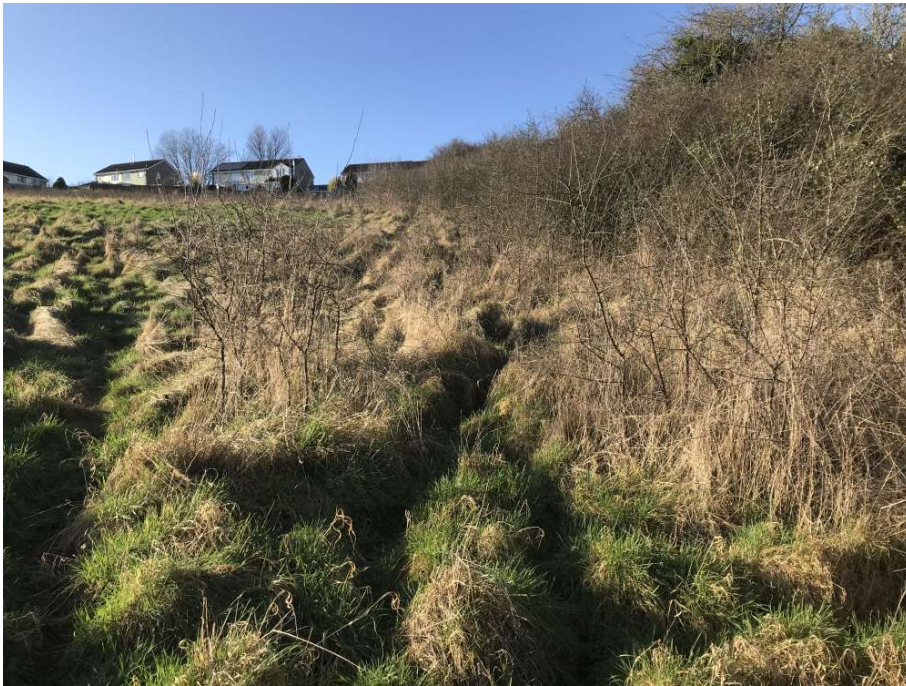
Since grazing on the land ceased, areas of scrub and coarse ruderal vegetation have been gradually spreading in from the margins of the site and with some areas of bramble and nettle developing within the grassland itself.

**Figure 18** – Blackthorn scrub spreading from the central dividing hedgerow (January 2022)

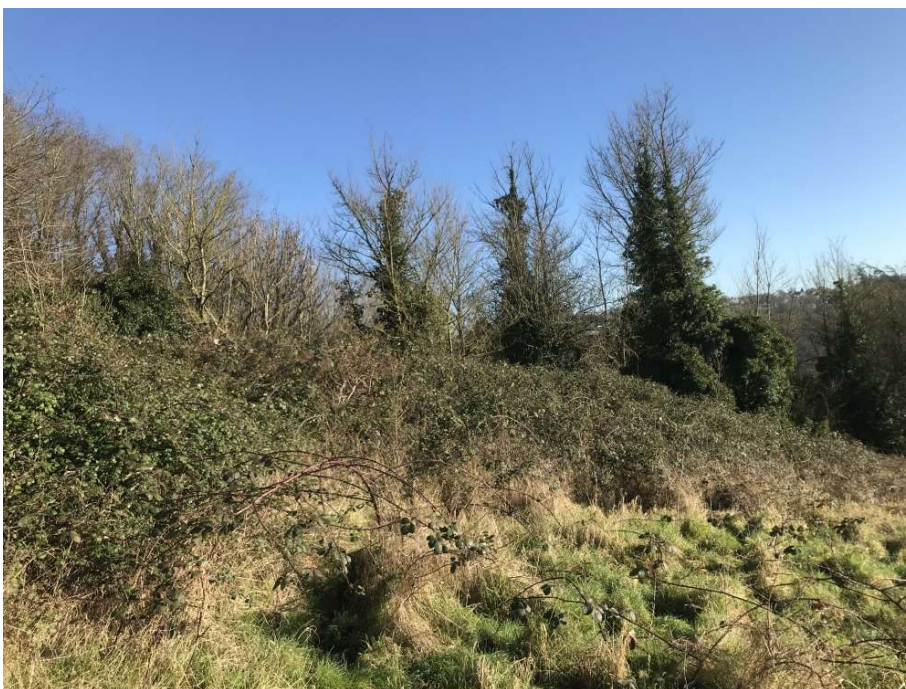
**Figure 19** – Bramble dominated area expanding from north boundary of site (January 2022)

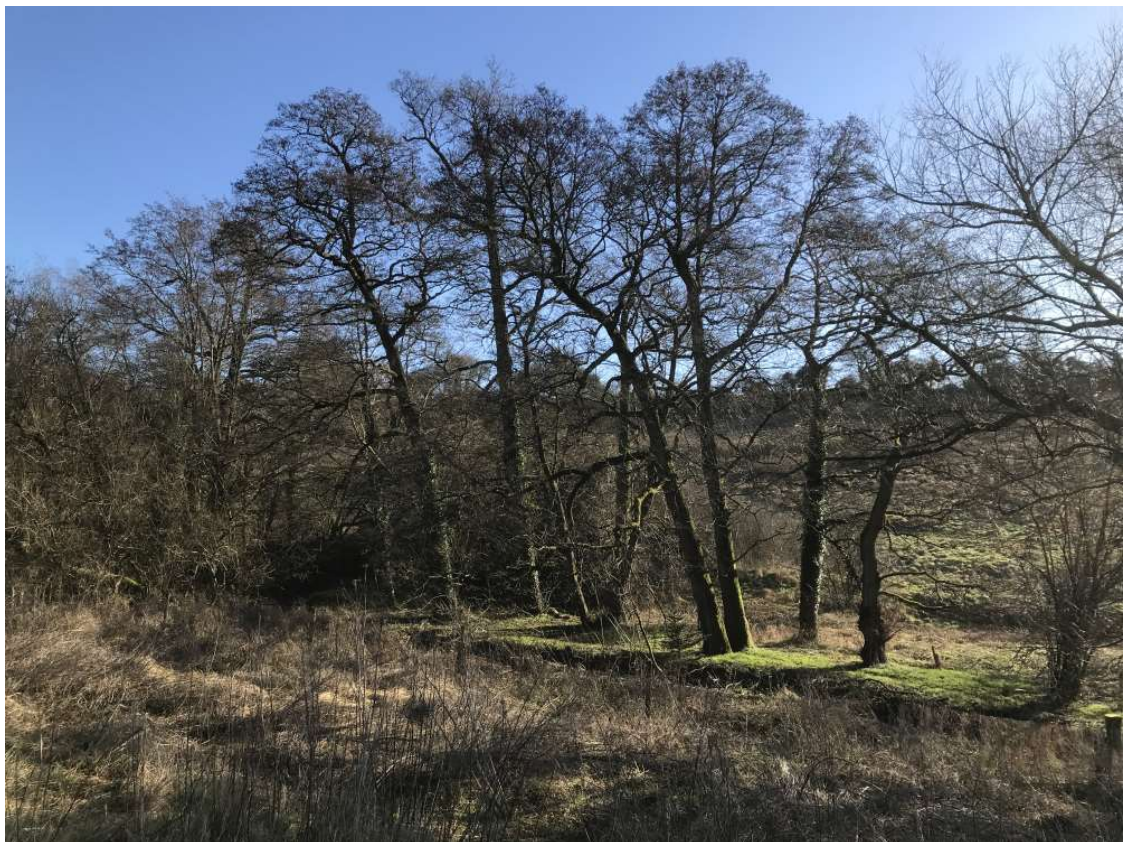
The banks are fairly consistently host to trees dominated by common alder, but with willow, hawthorn and ash also present. This woody vegetation makes the watercourse a potentially significant habitat for bats.

**Figure 20** – Beautiful stand of mature common alder on the SE bank of Waterside

Further ecological study of the watercourse is recommended to fully understand its features and potential.

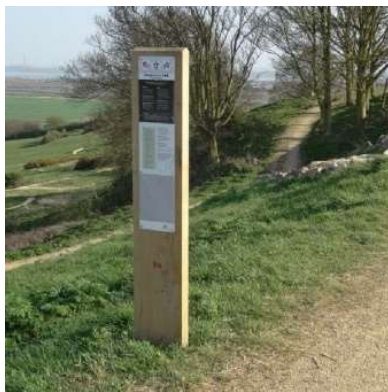
**Figure 22**  
*Example simple marker post for tertiary entrances*

It is proposed that these entrances are marked with a simple but substantial marker post or totem, giving the site name and Parish Council corporate identity.

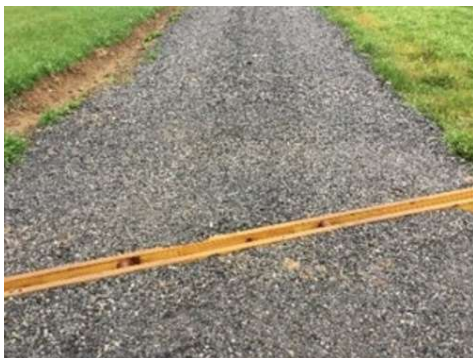
**Figure 24** – Example of timber drainage cut off

Sloping aggregate surface paths can be prone to gullying whereby flow of surface water builds up along the length reaching sufficient volume and velocity to causes channels to develop in the path surface. Over time these can become quite deep.

Where there is risk of this with new paths or improved surface to existing, drainage cut-offs should be installed to direct water to the side and off the path every few metres to avoid sufficient build-up of water to cause gullying.

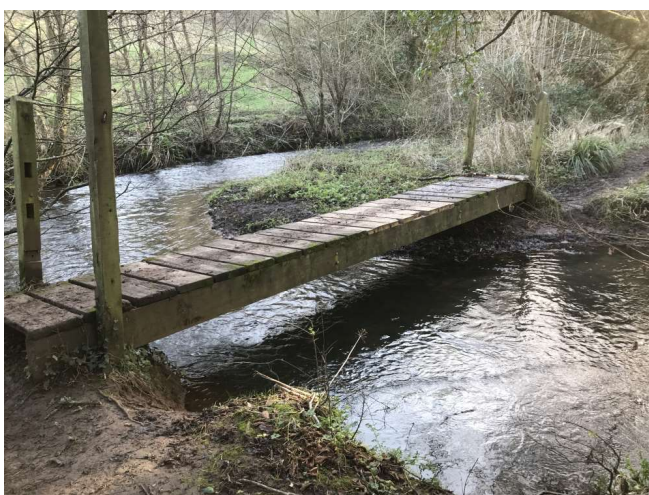
**Figure 25** – Footbridge at entrance G. Note steps at ends and lack of handrail

Similarly to the one at entrance H, both these have an awkward step at either end which could be removed by building up the ground. The Bridge at Entrance G previously had side rails, which have since been lost, leaving only four of the supporting posts. Consideration should be given to repairing and replacing these rails.

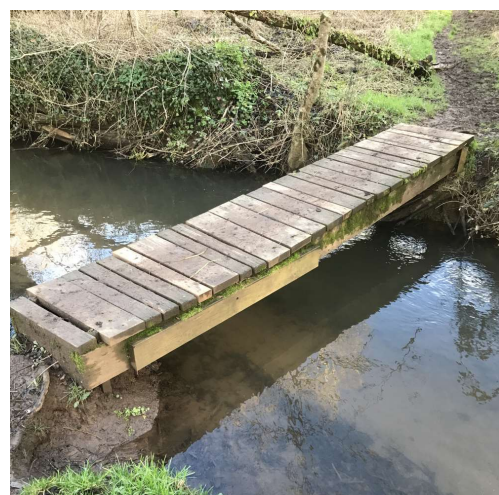
**Figure 26** – Footbridge at entrance F. Note repair to beam, lack of handrails, bank erosion and steps at each end

The bridge at entrance F is potentially more heavily used, connecting with the mown amenity space. It lacks any side rails and has been repaired at some point. This bridge would be best replaced with a new one, again with the ground built up at either end to provide easier access.

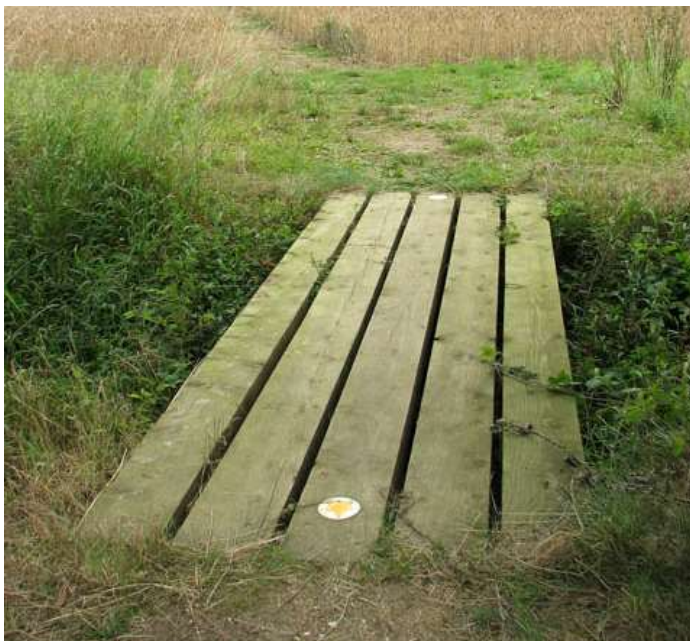
**Figure 27** – Example of suitable plank footbridge across channel

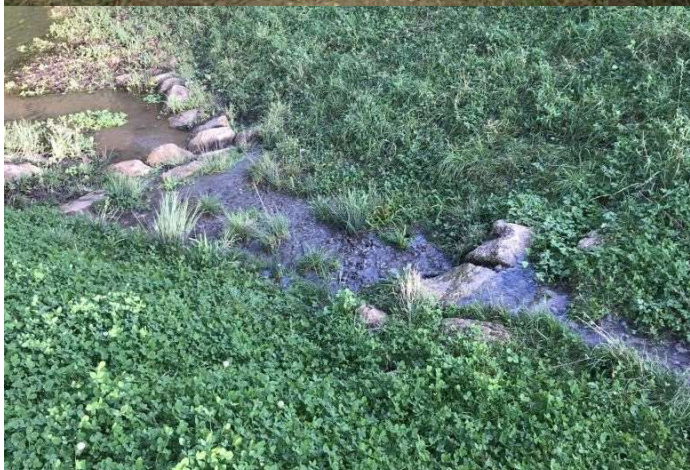
**Figure 28** – Example treatment for channel with boulders forming weirs and small pools behind

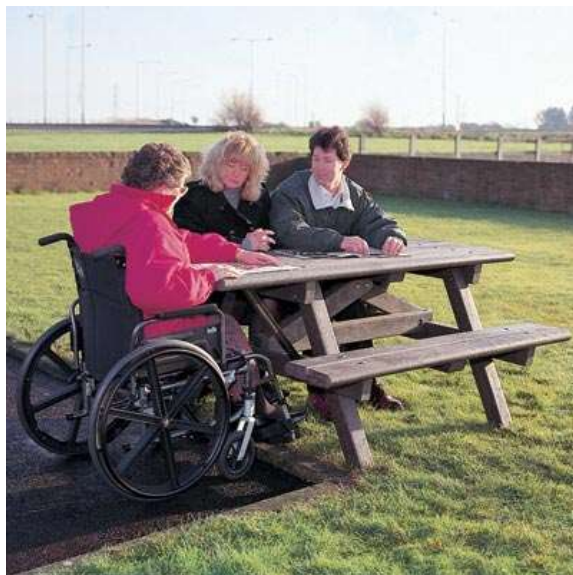
*Figure 29 - Example of fully accessible picnic bench with extended end for wheelchair use*

- Picnic benches should be of a design with an extended table to one end to allow disabled users to sit at the table.
- Provision of a level concrete pad below seats and picnic benches will allow them to be bolted down and remove the problem of maintain grass around them or the area below becoming muddy.

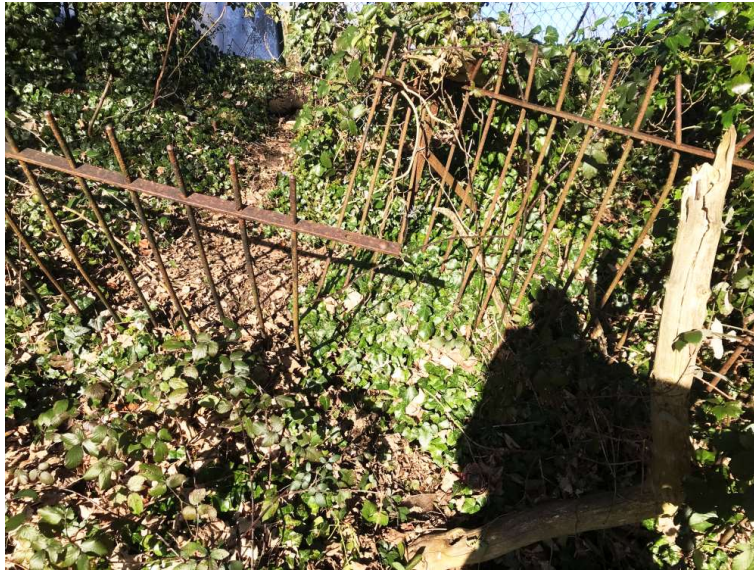
*Figure 30 – damaged railings to college site by the central pill box*

Much of this boundary is the historic boundary of South Hill House which previously stood on the college site. In some areas the old vertical bar railings are in poor condition and in need of repair.

It is desirable to keep the historic railings, especially in the vicinity of the pill box, however the college may be inclined to replace these with a cheaper, but less sympathetic fence. It would be worthwhile making contact with the college to discuss this boundary in conjunction with discussion about the pill box to try and ensure the best outcome.

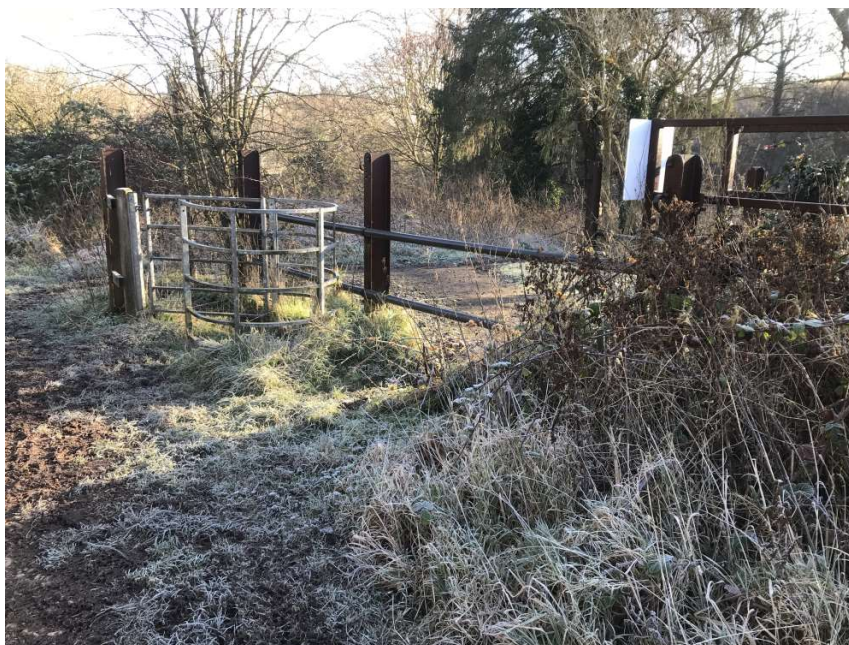
*Figure 31 – Redundant gates and metalwork at entrance D to be removed*

Ideally as part of improving the appearance and welcome of entrance D, and subject to detailed design proposals, these features need to be cleared.

It would thus be helpful to make further efforts to determine ownership of this land and seek permission from the landowner for removal.

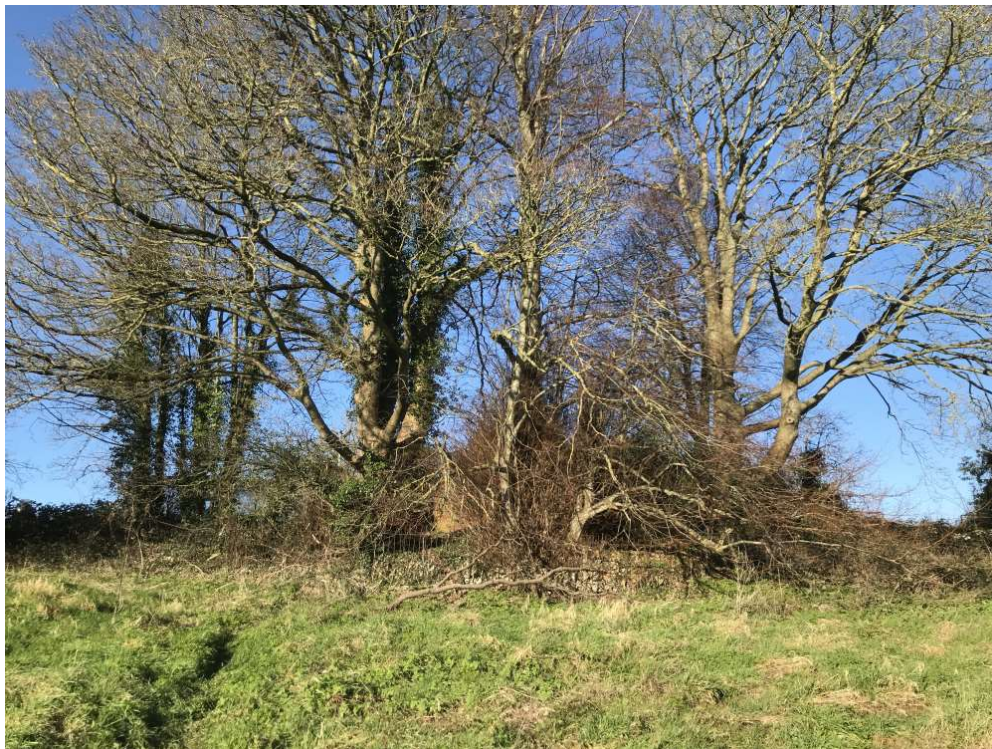
The central Pill Box is within the grounds of Bath College. This pill box is not publically accessible and is partially hidden by the dense epicormics growth from the base of the lime trees that surround them. Management of this growth and some slight crown lifting of the trees would be beneficial in helping to reveal the feature to the site enabling the wartime storey of the site to be told more effectively. It is however noted that this work would be of little benefit to the owners of these trees, so liaison and a potential offer to organise and pay for these works may be required.

**Figure 32** – Central pill box in ground of Bath College, largely hidden by vegetation

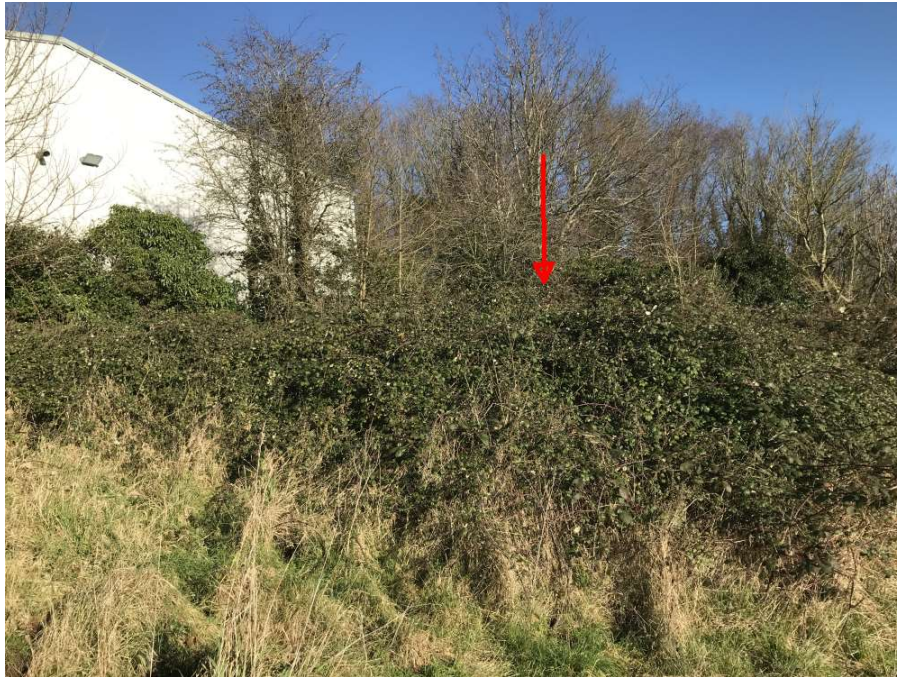
The eastern pill box is within the WPC ownership boundary, but is currently lost in dense bramble and is inaccessible. The following action is recommended:

**Figure 33** – approximate location of east pill box which is in WPC ownership

- Surrounding vegetation to be cleared to provide clear views of the pill box.
- Subject to agreement, this could include some clearance within church yard.
- Condition to be checked and any necessary remedial work / cleaning out undertaken.
- Consideration to be given as to whether 24-hour access to within the pill box will be made possible or if a gate / grille needs to be fitted. Access could be provided for special open days or educational events.
- Vegetation to be kept cleared to maintain access and views of the pill box from the valley, in the context of the other two.

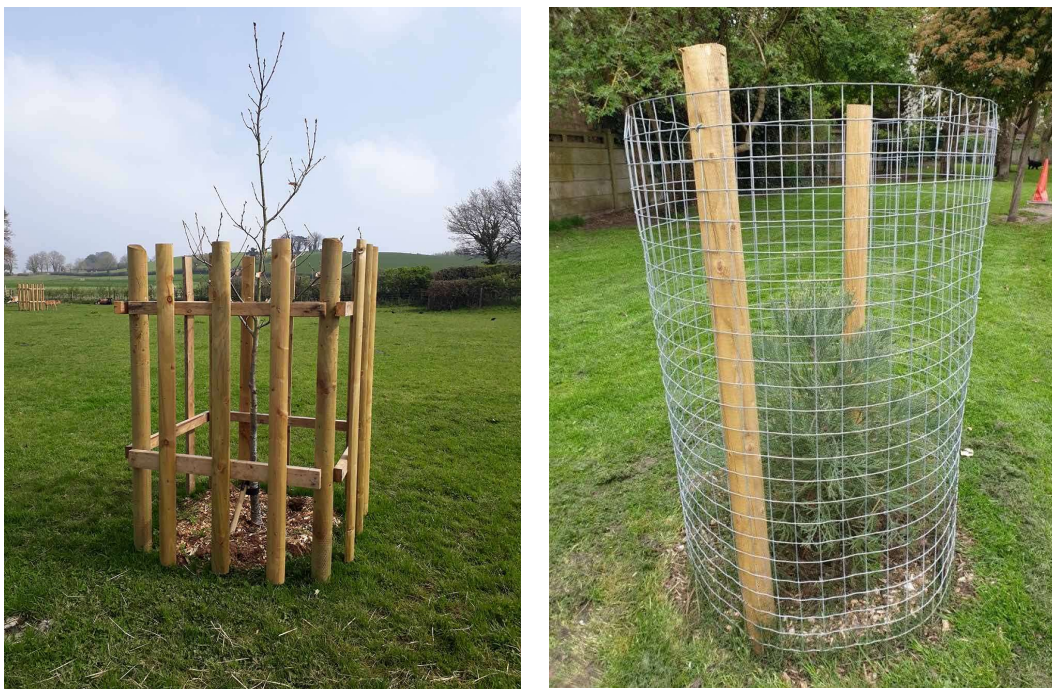
**Figure 34** – Typical timber and wire mesh tree guards

Control of vegetation growth around new trees will be vital to ensuring good establishment rates. Thus an area at least 1mx1m should be thoroughly cleared of vegetation, including roots before planting and a fully bio-degradable mulch mat (typically coir) applied around each tree.
